# **Damage mechanisms and non-destructive testing in the case of water ingress in CF-18 flight control surfaces**

Technical Memorandum

DCIEM TM 2000-098

August 2000

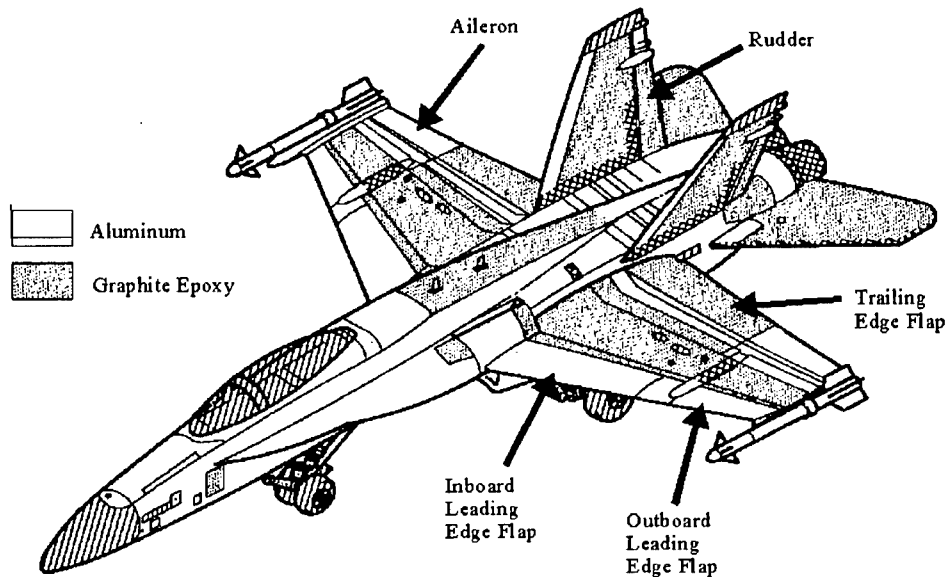
The CF-18 aircraft bears 12 flight control surfaces (Figure 1) with a honeycomb sandwich structure that provides a stiff lightweight structure. The flight control structure consists of an aluminum or graphite-epoxy composite (AS4/3501-6) bonded to an aluminum honeycomb core with a high-temperature adhesive.

Figure 1. CF-18 material distribution and flight controls from [1].

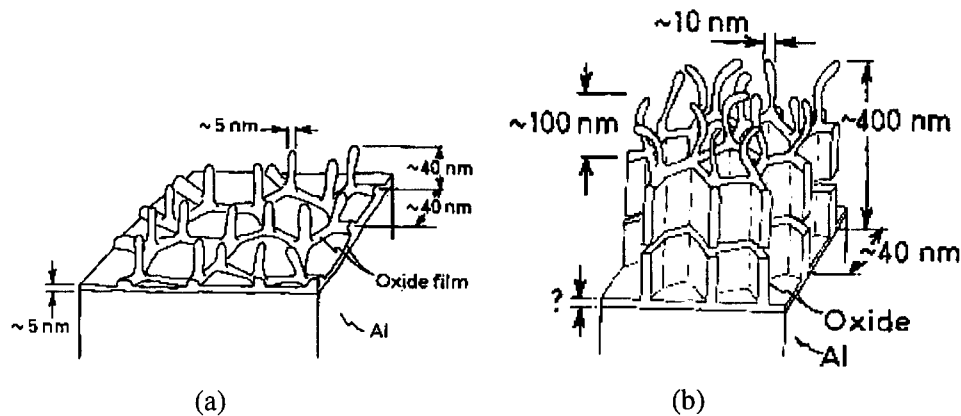
Figure 2. Oxide morphology produced on aluminum by (a) chromic acid anodizing (b) phosphoric acid anodizing from [9].

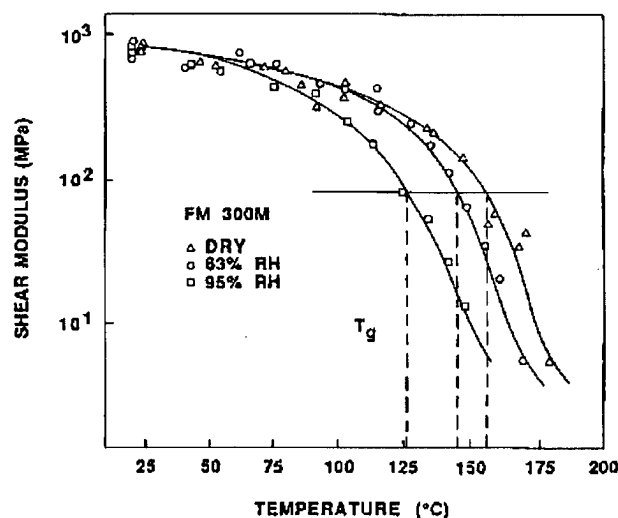
Figure 3. Values of shear modulus versus temperature at various moisture levels from [18].

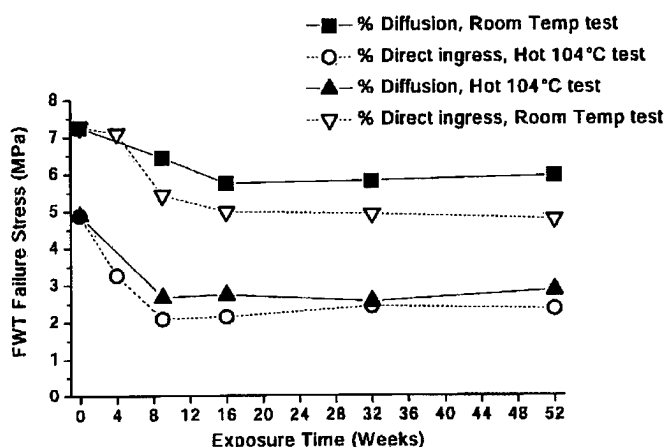
Immersion of aluminum joints in water or exposure to high humidity normally leads to a substantial loss in joint strength, but exposure to moderate humidities for long periods does not normally lead to permanent strength loss [9]. Hence, this effect is relatively unimportant compared with environmentally induced loss of adhesion at, or close to, the metal oxide/adhesive interface due to water ingress. Although the difference between the strength for direct ingress and diffusion ingress specimens is not great when wet/moist (Figure 4), the failure mode is fairly different. After long-term exposure, the diffusion ingress samples show cohesive failure in all cases (i.e., through the adhesive) while direct ingress samples failed at the adhesive to core interface [3].

Figure 4. FWT test results for direct moisture ingress and diffusion moisture ingress tested under room temperature and 104°C test conditions from [3].

This difference in the degradation mechanisms between diffusion and direct ingress cases is supported when considering the dry recovery of the specimens (Table 1). The diffusion specimens recover much of their original properties which indicates that reductions in Flatwise Tension (FWT) strength are due to moisture in the adhesive causing plasticisation and not due to any permanent degradation of the adhesive bond. On the other hand, the direct ingress specimen did not recover their full FWT strength. This loss of strength indicates that some level of permanent adhesive bond degradation has occurred [3].

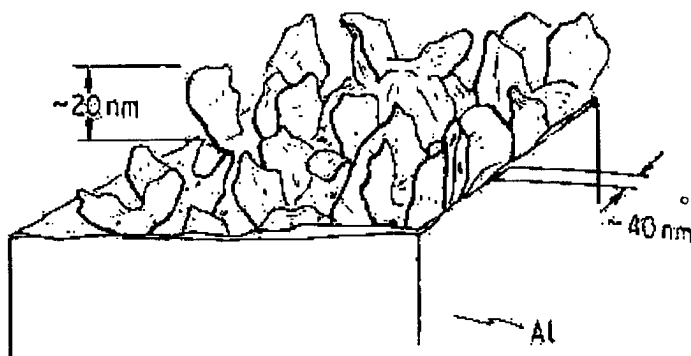
Weakening of the oxide by hydration involves permeation of water through the adhesive, hydration of the oxide and cleavage of the mechanically weak hydrated oxide [11,24,25]. Specifically, water initially passivates the oxide film and protects the metal from attack during an "incubation" period. The intense hydration activity will convert the original oxide to a hydroxide. It is the hydration of aluminum oxide on the adhesive/adherend interface that likely plays an important role in joint failure. Venables [26] found that pseudo-boehmite (Figure 5) may be created by the reaction

Figure 5. Characteristic "cornflake" structure associated with pseudo-boehmite morphology from [9].

The conversion of aluminum oxide to hydroxide is accompanied by a threefold increase in thickness, and the adhesion of the hydroxide to aluminum is sufficiently weak that once the hydroxide forms, it separates from the adherend and leads to bond failure. Experiments [26]

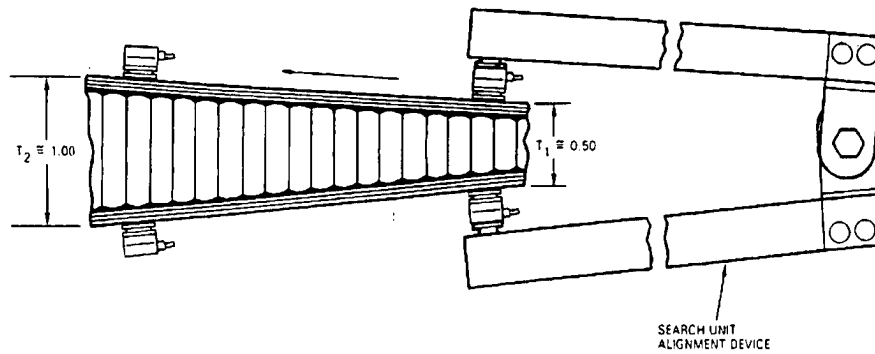
Through-transmission ultrasonic testing can be applied on-aircraft using a search unit alignment device (e.g., Figure 6); however, this technique provides discrete measurements for a manually generated inspection grid. The technique is effective in detecting disbonds and water in cells; it requires that both transducers be aligned axially on either side of the specimen and be in contact with the surface. This can be achieved for field inspections but better results can be obtained by removing the component from the aircraft and inspecting it with a C-scan ultrasonic testing system. This technique allows the C-scan mapping of the area inspected where sound attenuation appears as colour changes. Results obtained with the C-scan ultrasonic testing system are shown in Figure 7.

Figure 6. Through-transmission search unit from [28].

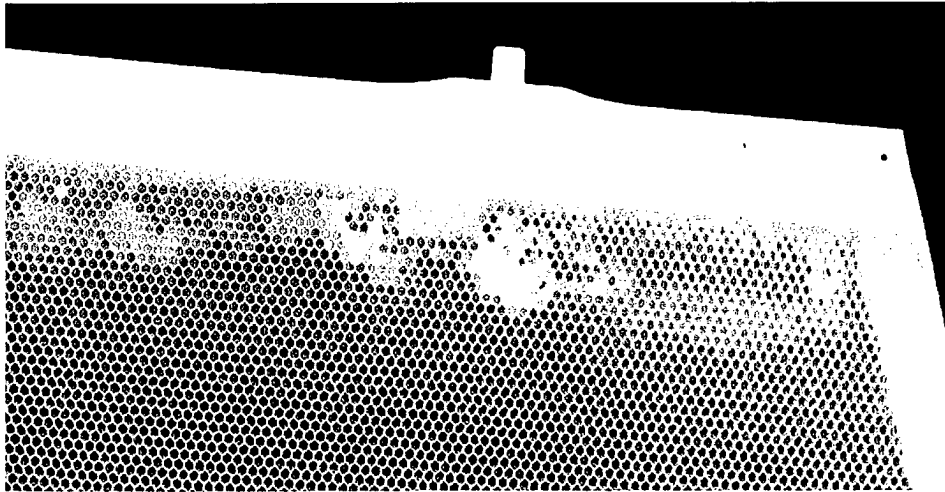
X-rays are routinely used in the field for core damage (including corrosion) and the procedure is available for the inspection of CF-18 flight controls [29]. Of all applicable NDT techniques, radiography is considered the most effective for detecting core damage [1]. X-ray also has the potential to detect disbands under some circumstances and provided that technicians have proper training and experience.

Figure 8. X-Ray inspection results showing water along the leading edge of the rudder.
